Stream Inventory Report

San Jose Creek

2006

Prepared by: Jennifer Nelson (California Department of Fish and Game)
Eileen Baglivio and Tim Kahles (California Conservation Corps)

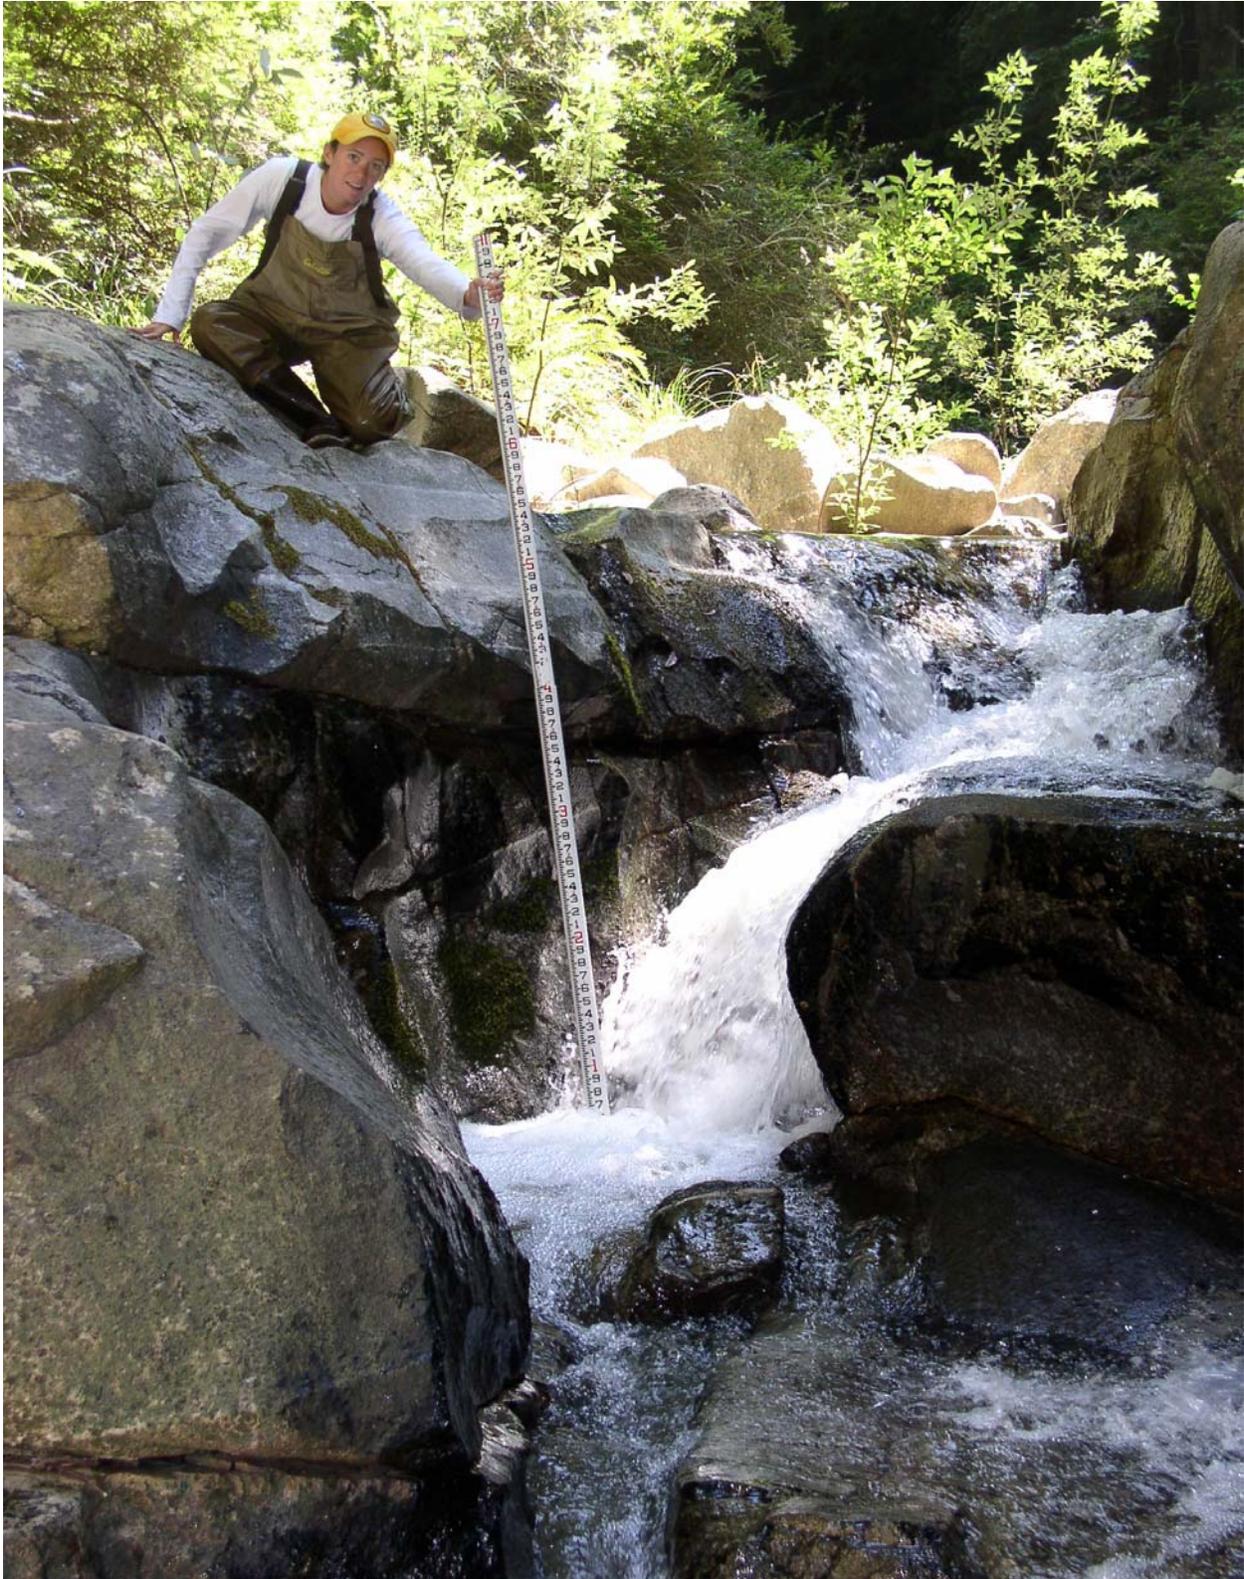
The seven bedrock and boulder cascades ranged in length from 9 to 33 feet and ranged in height from 3 to 7 feet. The only cascade that was considered a potential impediment to adult fish passage under certain flows was habitat unit 305 at stream mile 2.85 (Figure 4). The cascade ranged from 5 to 7 feet high with a pool at the base that had a maximum depth of 2.5 feet. Towards the right bank, there was a 0.7 foot high bedrock sheet beneath a 7 foot high bedrock outcrop. Towards the left bank, a 4 foot high cascade was beneath a 2.2 foot deep pool before a final jump over a 3.5 foot high angled back bedrock section at the upper part of the cascade.

Figure 4. The boulder/bedrock cascade in habitat unit 305, San Jose Creek, 2006.

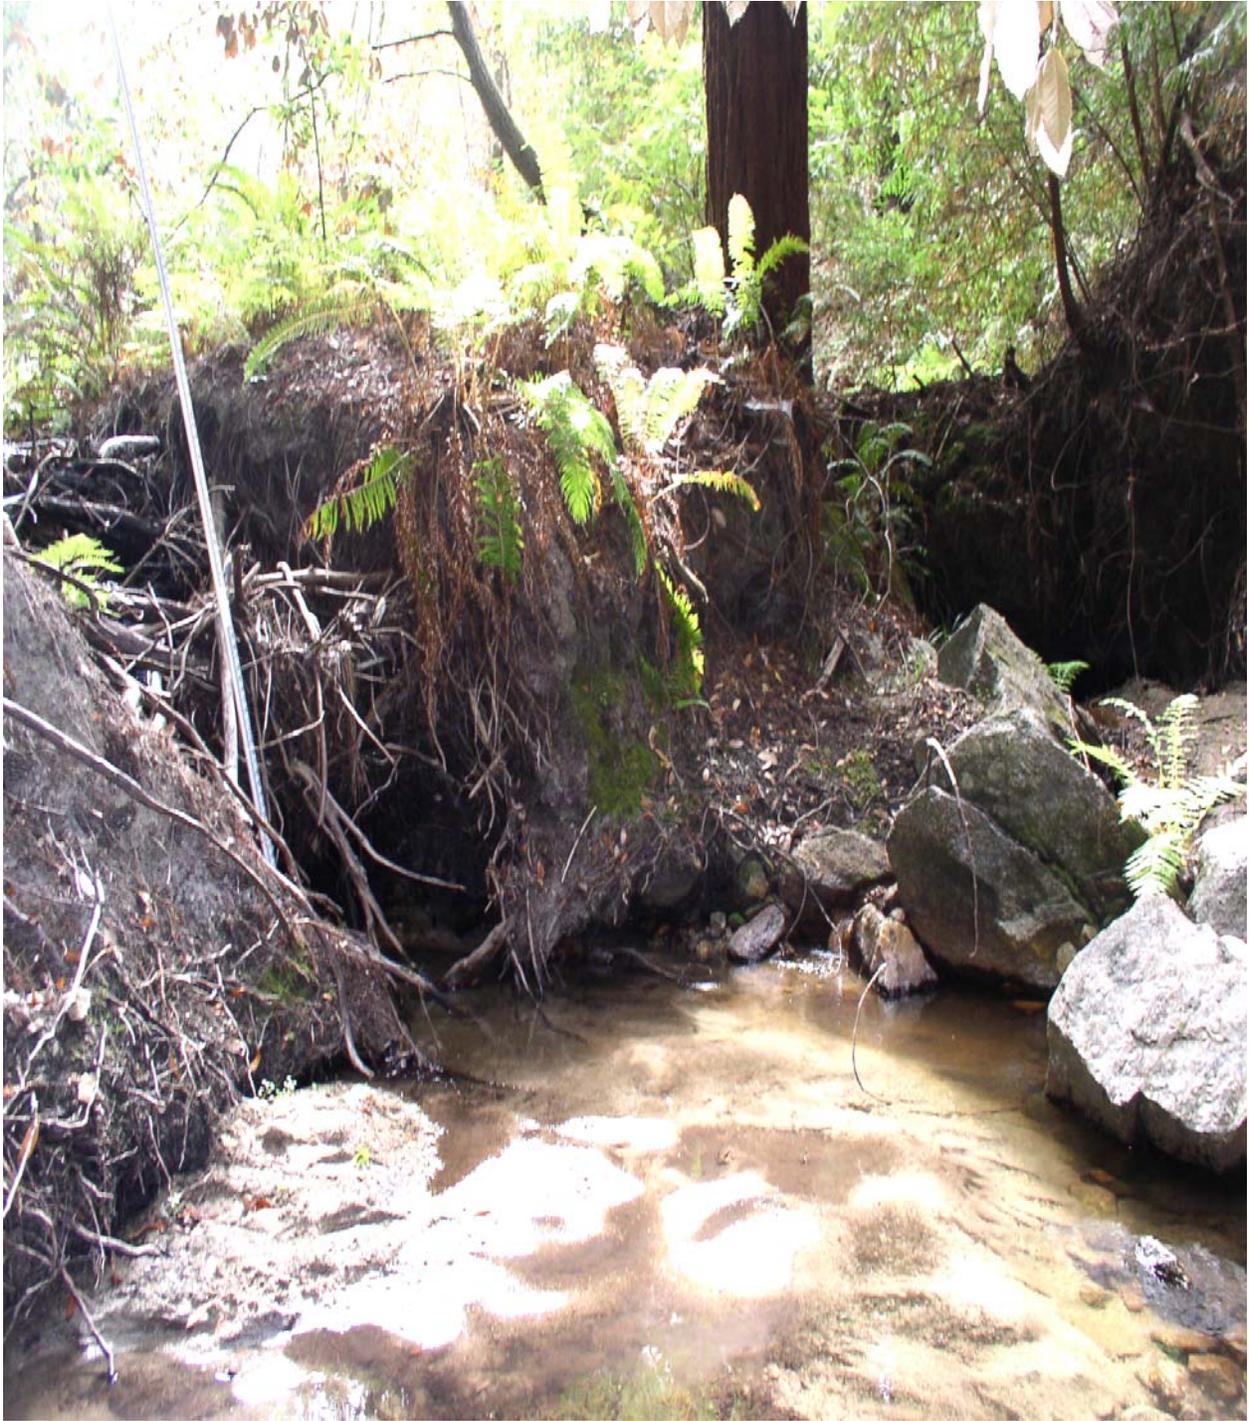
Approximately 70 log jams composed of small and/or large woody debris were identified within the surveyed reach, the majority of which would not impede fish passage or become barriers to upstream migration. In some cases the log jams were retaining sediment upstream while others allowed free passage of stream flow and fish beneath. Two log jams that may be impediments under certain winter flow conditions were located in habitat units 957 and 1050. Habitat unit 957 (stream mile 7.5) was the most significant and, at the time of survey, was possibly the (temporary) upper limit of anadromy. A redwood clump fell into the original channel from the left bank causing the stream flow to divert to, and scour out a new channel on the right bank side by head cutting upstream until it merged with the original channel. The right bank channel is 8 higher than the channel below and the stream is flowing beneath roots and woody debris (Figures 5 and 6). The original channel upstream of the fallen redwoods and head cut section was filled with sand, inundating the lower portions of tree trunks (Figure 7).

Figure 5. Diverted channel in unit 957, San Jose Creek, 2006.

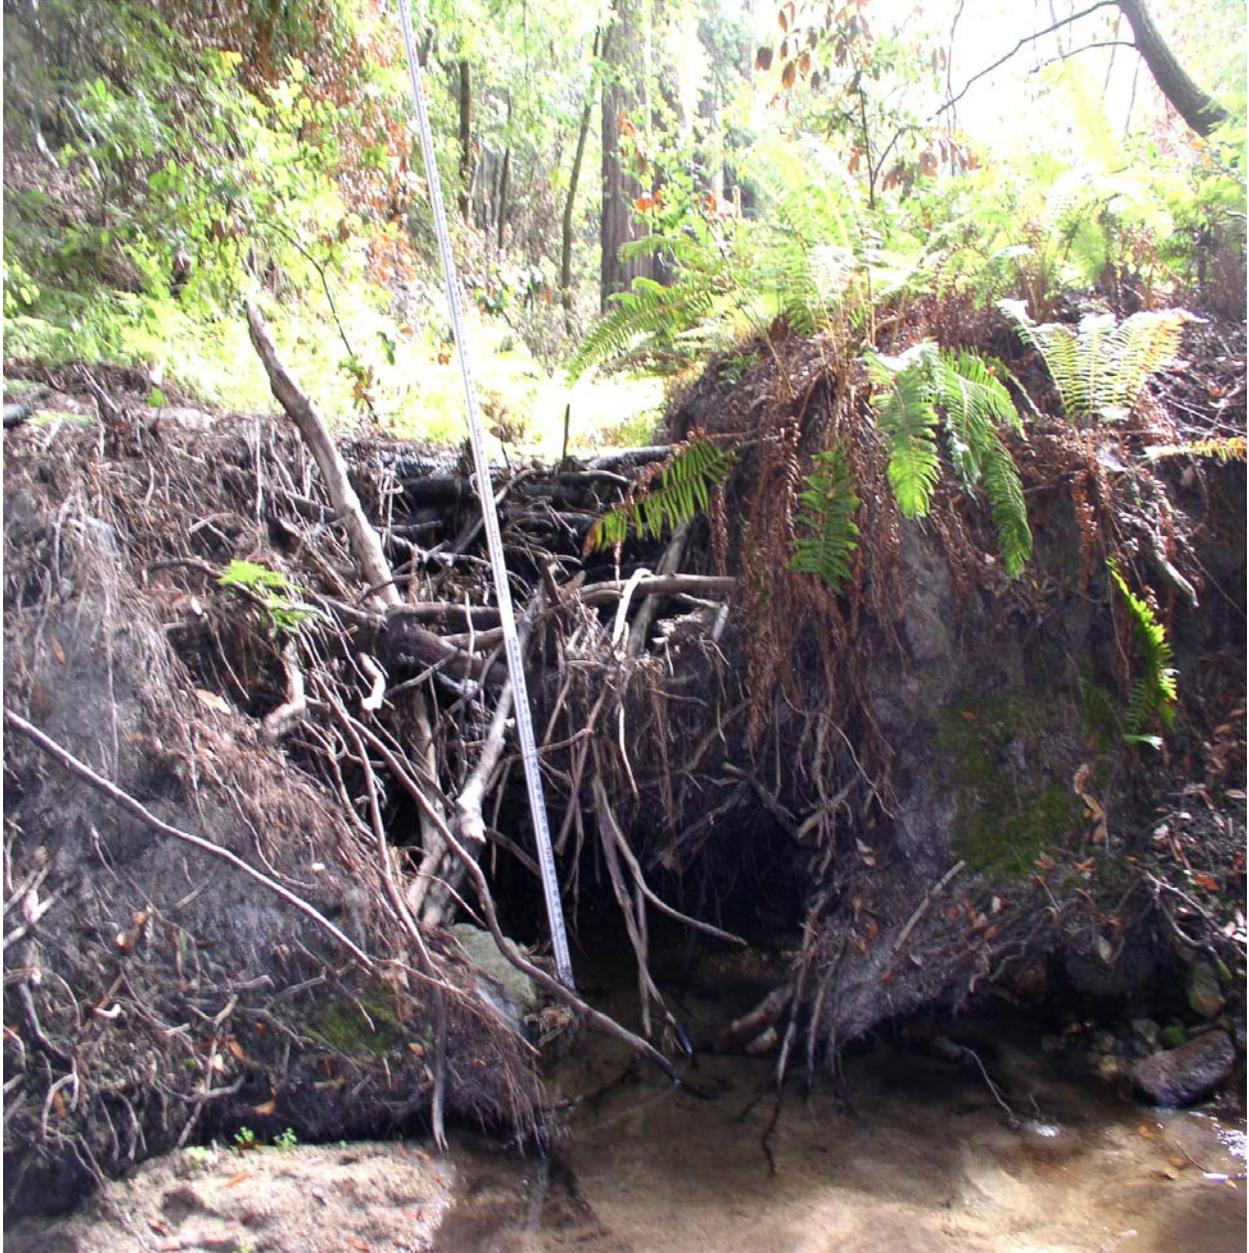
Figure 6. The log jam and small woody debris impediment in unit 957, San Jose Creek, 2006.

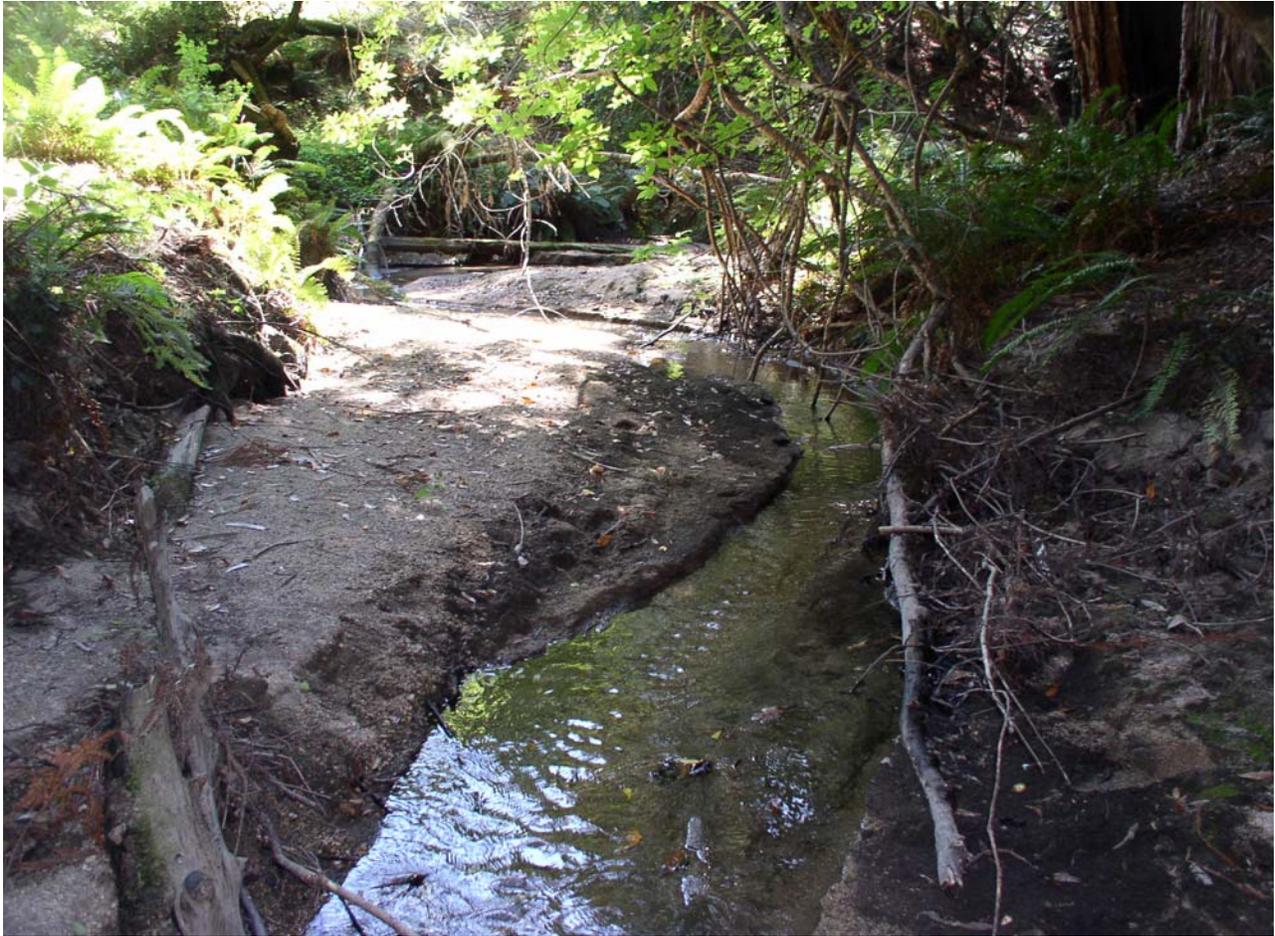
Figure 7. The original channel upstream of the log jams in unit 957, San Jose Creek, 2006.

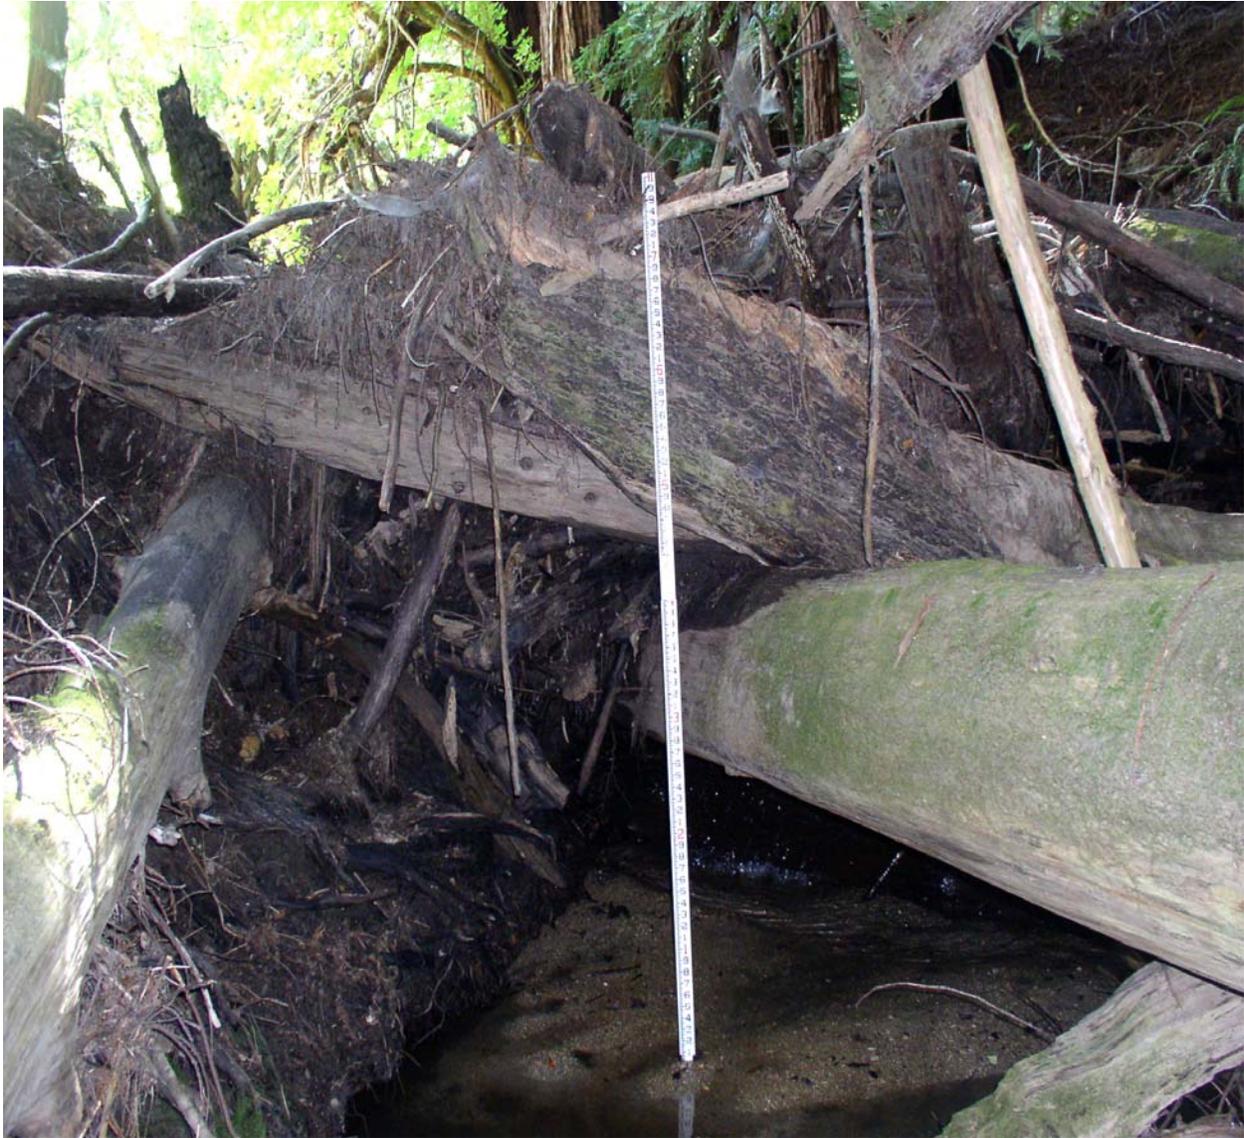
A log jam in habitat unit 1050 (stream mile 8.0) is also problematic for passage. The log jam is 8 feet high, 22 feet long, and spans the width of the channel. Just upstream of the low jam, the channel has aggraded 8 feet. A new channel is starting to scour or head cut into the left side of the creek (Figure 8).

Figure 8. Log jam in unit 1050, San Jose Creek, 2006

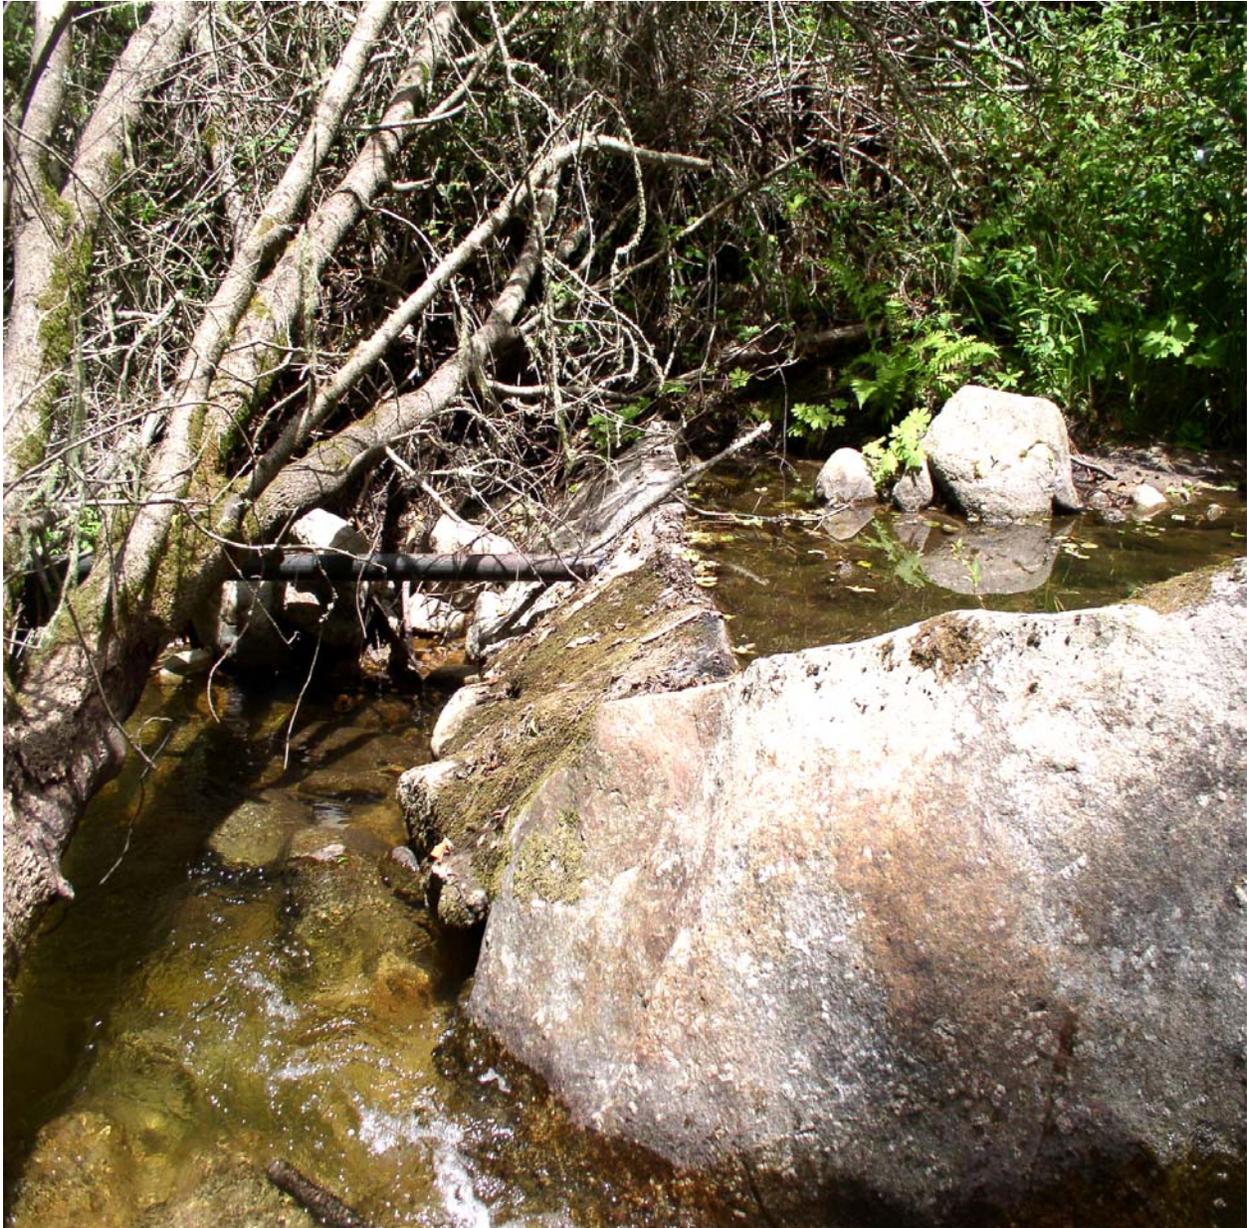
One concrete dam and one concrete weir, located in habitat units 156/157 and 748 respectively, were noted during the survey. The dam in unit 156 extends 12 feet into the creek channel from the right bank and is 3.5 feet high with the face of the dam sloped back at a 45 degree angle. Upstream of the dam, the creek channel has aggraded three feet. Fish passage on the left bank side is unaffected (Figure 9).

Figure 9. Concrete dam in units 156 and 157, San Jose Creek, 2006.

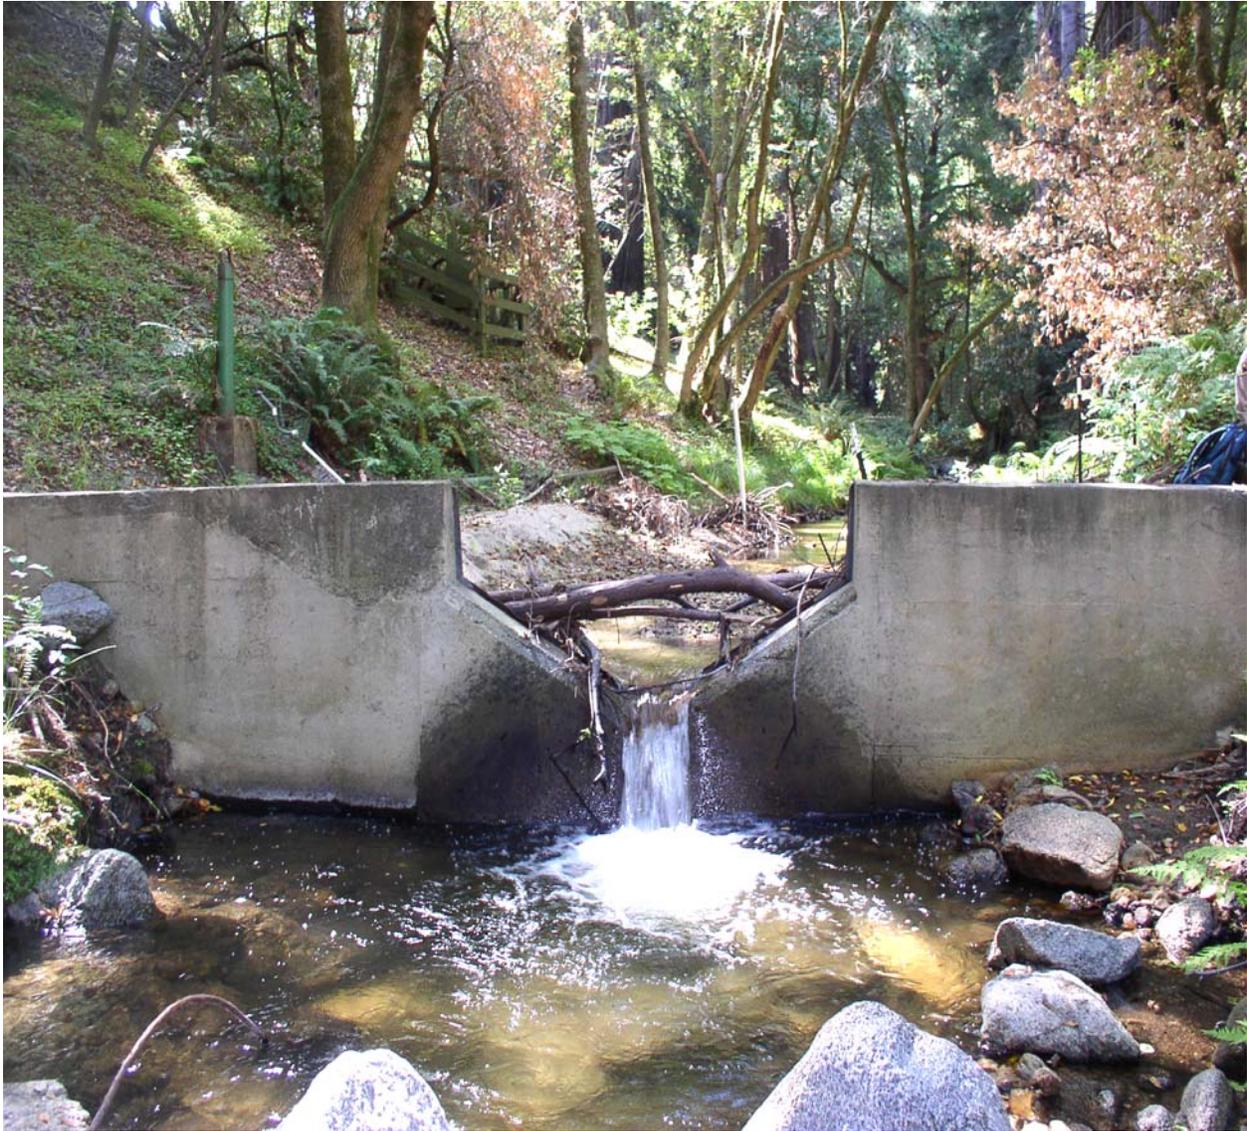
In unit 748, a concrete weir spans the 36 foot wide creek channel. The structure has a V-shaped notch that ranges from 7 feet wide at the top to 0.9 feet wide at the bottom. The jump from the stream up to the notch is a 2.1 feet high and the pool below is 2.2 feet deep. Upstream, the channel has aggraded 1.8 feet. The structure is being undermined on the left bank side (Figure 10).

Figure 10. The concrete weir/ flashboard dam in unit 748, San Jose Creek, 2006.

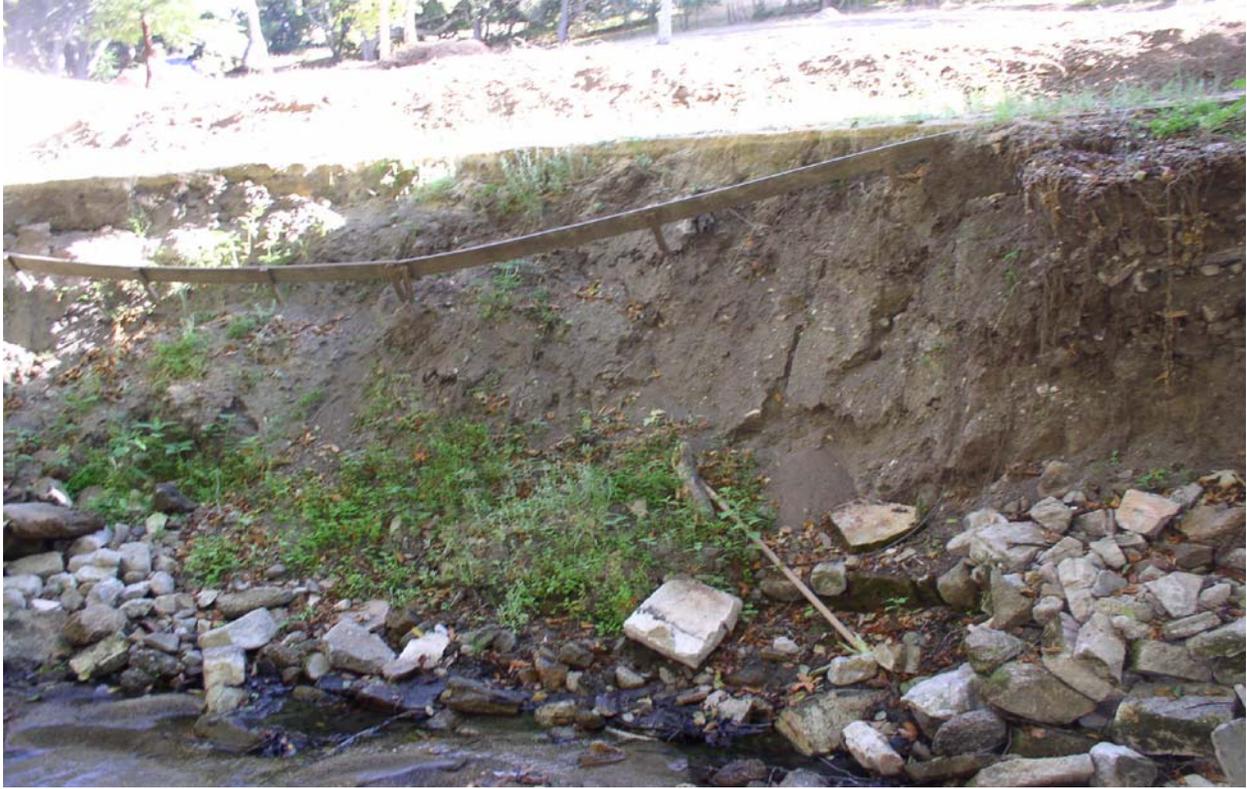
Obvious sources of fine sediment in San Jose Creek included the road crossings and some bank erosion sites, the most significant of which was on a private parcel where all the riparian vegetation was removed (Figure 11). No obvious landslides or other areas of mass land movement were observed.

Figure 11. A bank failure site on San Jose Creek, 2006.

- 1) Excessive sediment deposition has reduced and degraded spawning and rearing habitat throughout most of San Jose Creek. Although most of the sediment was deposited or released during the 1997-98 winter storms, there are still active point and non-point sources of sediment contributing to the creek. It is recommended that active and potential sediment sources throughout San Jose Creek watershed be identified, mapped, and prioritized for remediation. The assessments should focus on roads, building sites and other activities in the upper watershed, and landslides.
