**POLE CREEK**

**STREAM INVENTORY REPORT**

Prepared by:  
Dave Kajtaniak  
Fisheries Biologist  
Pacific States Marine Fisheries Commission and  
California Department of Fish and Game  
4665 Lampson Ave, Suite C  
Los Alamitos, CA 91711

February 15, 2008

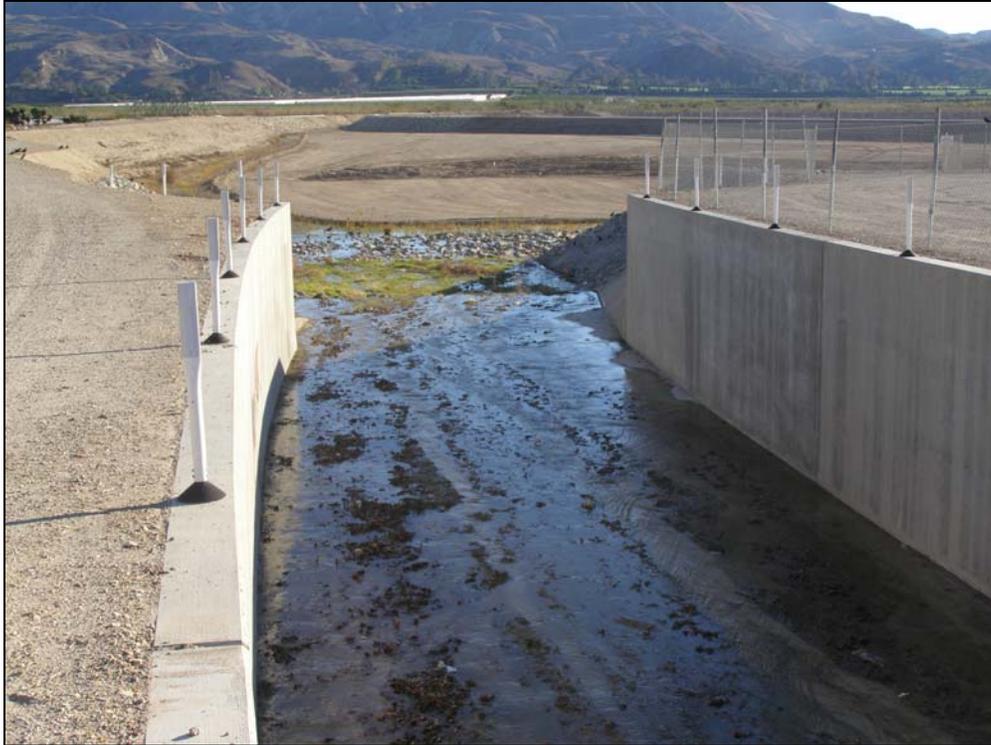
**Photo 1.** View of Pole Creek flowing into retention basin.

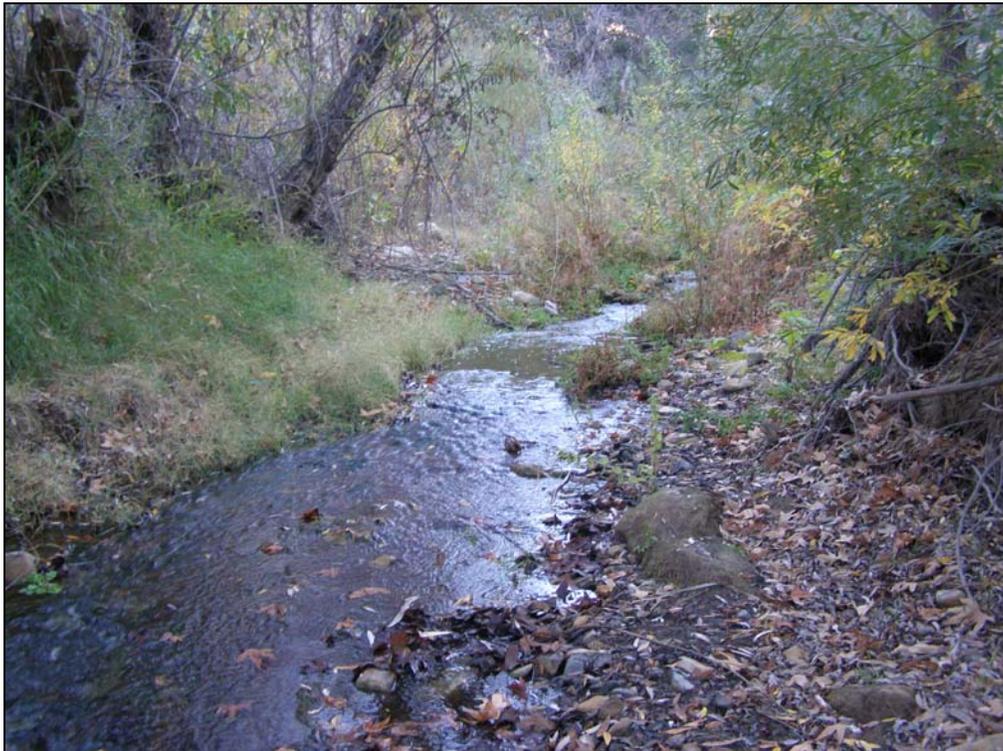
**Photo 1.** View of lower Pole Creek

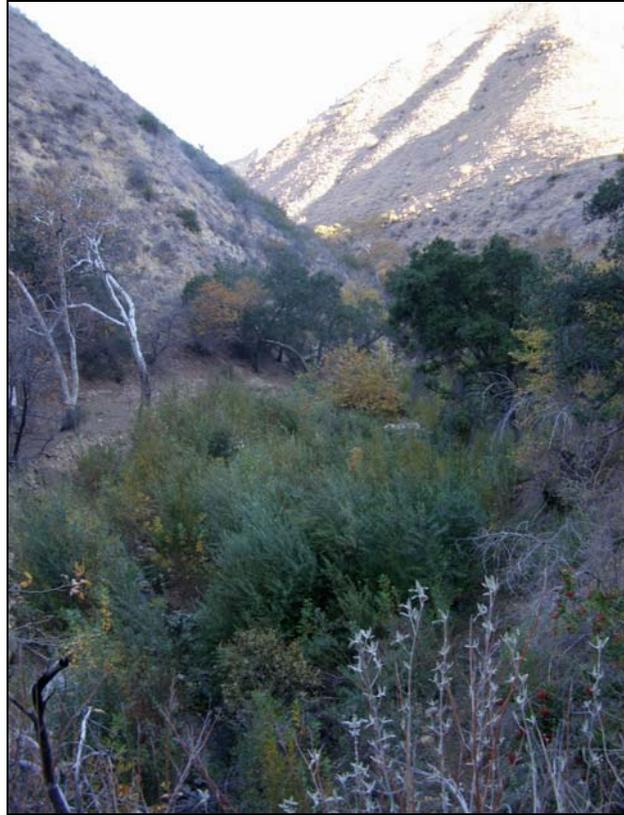
**Photo 2.** View of Pole Creek downstream of confluence with N.F. Pole Creek

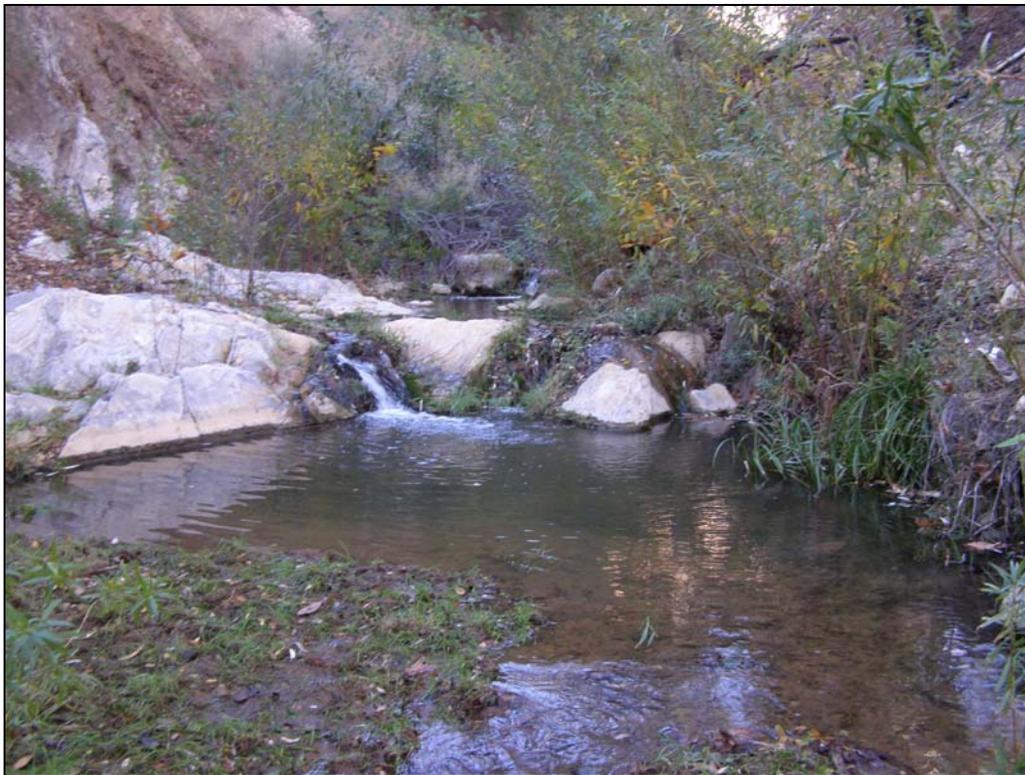
**Photo 3.** View of Pole Creek (mid to upper portion of the survey).

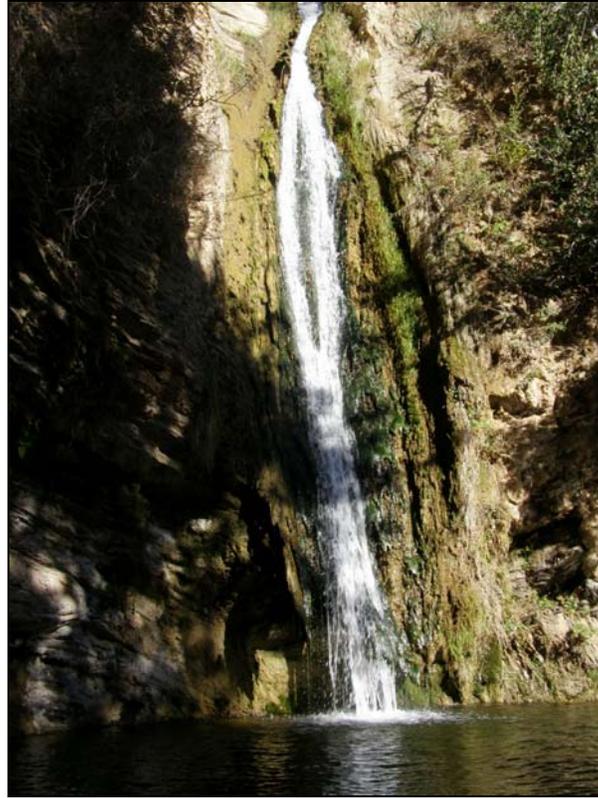
Pole Creek is a C4 channel type for 7,226.00 feet of the stream surveyed (Reach 1), a B4 channel type for 6,444.60 feet of the stream surveyed (Reach 2), and a B1 channel type for 2,399.00 feet of the stream surveyed (Reach 3). The survey concluded at a 40-foot waterfall, a natural barrier to all upstream migration.

**Photo 4:** Pole Creek, end of survey at 40 foot waterfall.

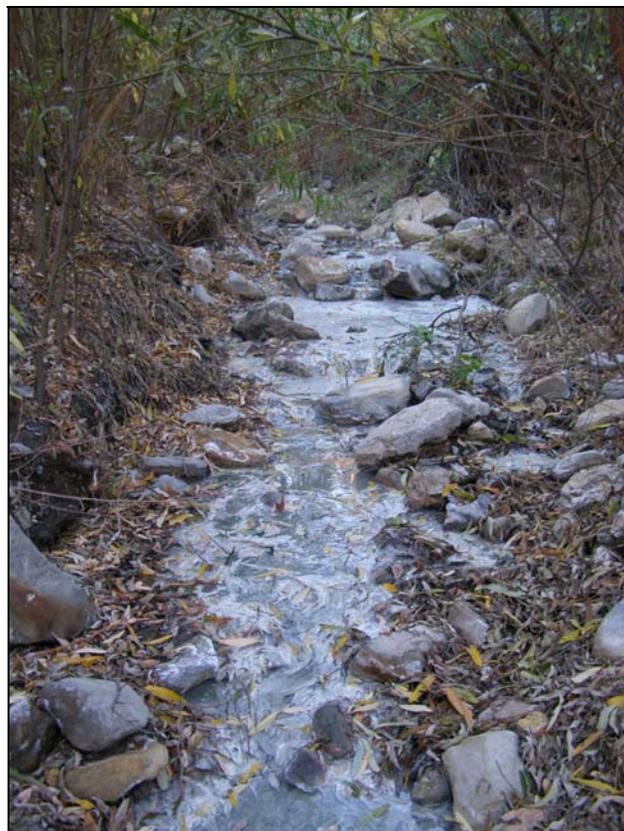
**Photo 5.** North Fork Pole Creek near the confluence with Pole Creek
