**POLE CREEK**

**STREAM INVENTORY REPORT**

Prepared by:  
Dave Kajtaniak  
Fisheries Biologist  
Pacific States Marine Fisheries Commission and  
California Department of Fish and Game  
4665 Lampson Ave, Suite C  
Los Alamitos, CA 91711

February 15, 2008

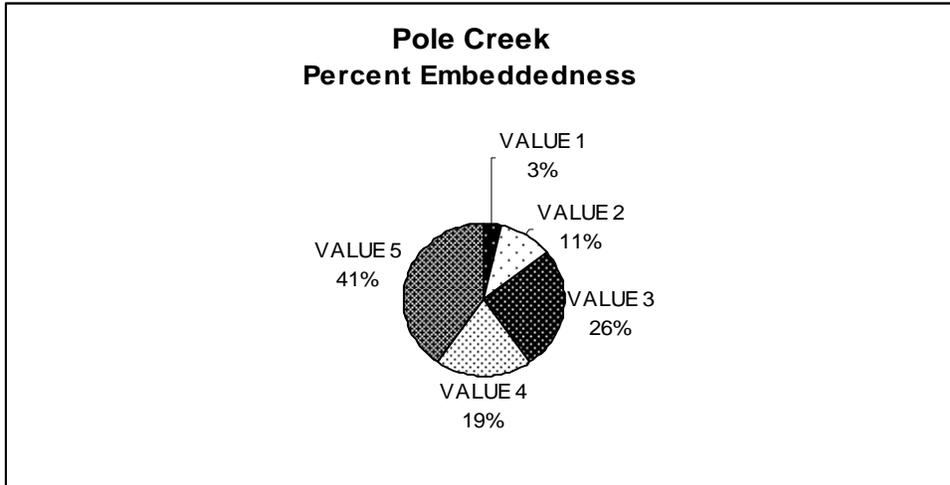
Graph 6 Percent Embeddedness

The depth of cobble embeddedness was estimated at pool tail-outs. Of the 60 pool tail-outs measured, 2 had a value of 1 (3.3%); 7 had a value of 2 (11.7%); 15 had a value of 3 (25%); 11 had a value of 4 (18.3%); and 25 had a value of 5 (41.7%) (Graph 6). On this scale, a value of 1 indicates the best spawning conditions and a value of 4 the worst. Additionally, a value of 5 was assigned to tail-outs deemed unsuited for spawning due to inappropriate substrate such as bedrock, boulders, or other considerations. Most of the value 5 ratings were a result of boulders and bedrock located at the pool tail-out.

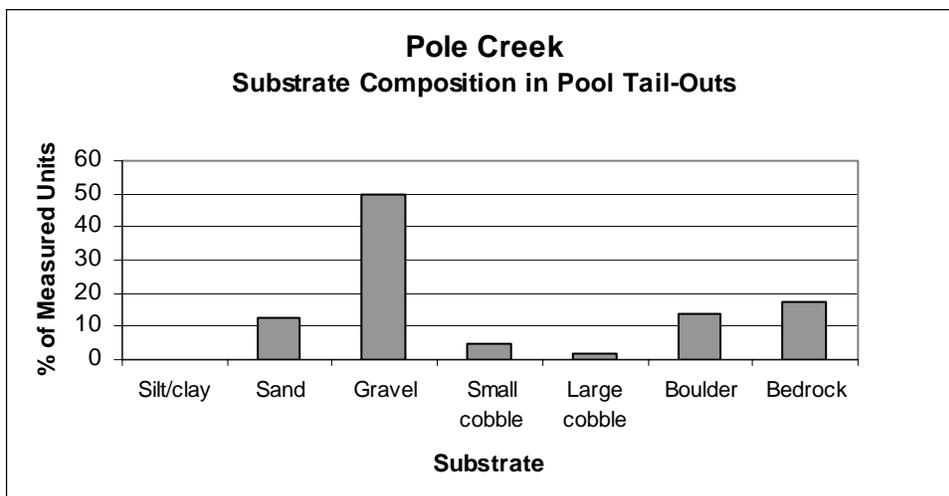
Table 6 summarizes the dominant substrate by habitat type. Graph 8 depicts the dominant substrate observed in pool tail-outs. These dominant substrate types were gravel, composing 50% of pool tail-outs, and bedrock occupying 17% of the pool tail-outs.

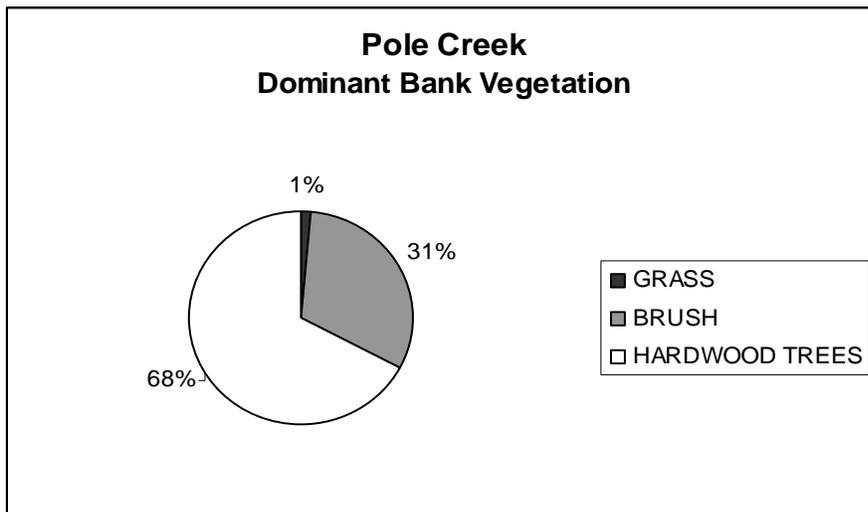
Graph 11 Dominant bank vegetation

For the stream reach surveyed, the mean percent right bank vegetated was 66%. The mean percent left bank vegetated was 53%. The dominant elements composing the structure of the stream banks consisted of 66% cobble/gravel, 18% sand/silt/clay, 9% bedrock, and 7% boulder (Graph 10). Deciduous trees were the dominant vegetation type observed in 67% of the units surveyed. Additionally, 31% of the units surveyed had brush as the dominant vegetation type, and only 1% had grass as the dominant vegetation (Graph 11).
